Manhole Inspection Summary

Manhole # S45AA_012MH

Insp Date: **8/19/08 9:59 AM**

Location Address: **MCELDERRY**

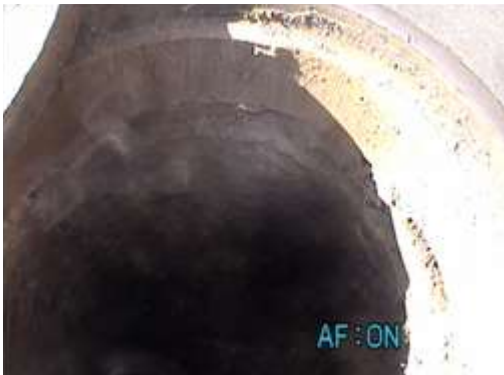
Defect 1

☒ **Leaks**

Frame leaks

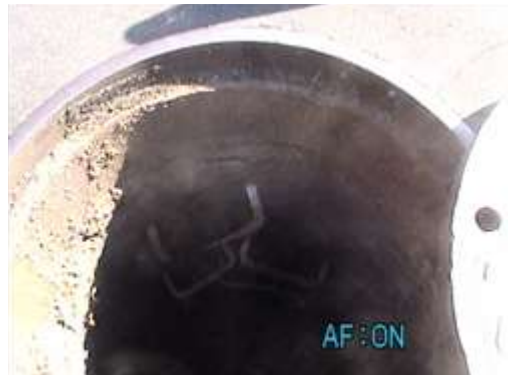
Defect 2

Infiltration: ☐ None ☐ Joint ☐ Cracks ☒ **Mortar** ☐ Roots ☐ Wall

Infiltration: ☐ None ☐ Joint ☐ Cracks ☐ Mortar ☐ Roots ☒ **Wall**

Infiltration

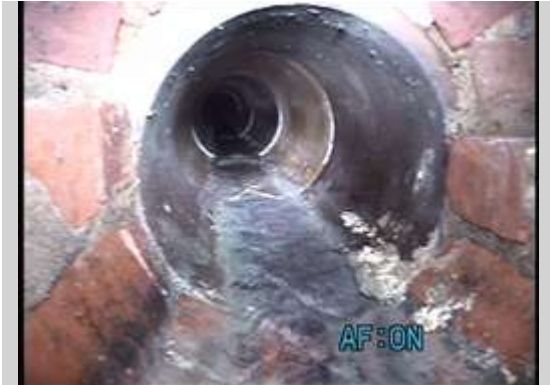
12 O'Clock Outflow

Pipe Height: **8.4** (in.) Rod and Bar (Angled)
Pipe Material: **Clay** ☐ Pipe Lined
Invert Depth: **11.05** (ft.) Flow Characteristics: **Fast**
Deposits: ☒ None ☐ Mud ☐ Sludge ☐ Debris ☐ Grease
Silt Depth: (in.) Deposits Extent:
Infiltration: **None** Pipe Seal Cond: **Sound**

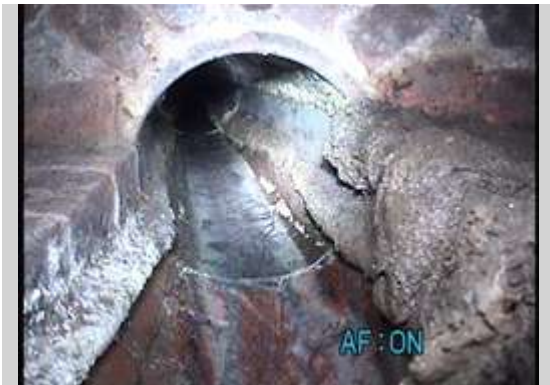
5 O'Clock Inflow

Pipe Height: **8.4** (in.) Rod and Bar (Angled)
Pipe Material: **Clay** ☐ Pipe Lined
Invert Depth: **10.80** (ft.) Flow Characteristics: **Fast**
Deposits: ☒ None ☐ Mud ☐ Sludge ☐ Debris ☐ Grease
Silt Depth: (in.) Deposits Extent:
Infiltration: **None** Pipe Seal Cond: **Sound**

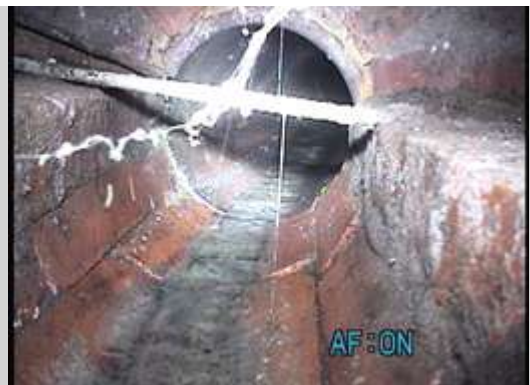
7 O'Clock Inflow

Infiltration: **None** Pipe Seal Cond: **Sound**
